Space Shuttle Body Flap Actuator Bearing Testing for NASA Return to Flight

Abstract

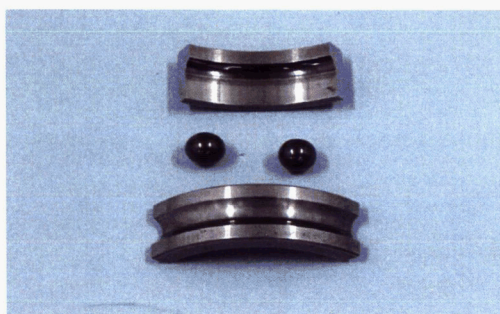
Figure 3. Black bearing after sectioning and cleaning

Visual inspection of P/N 5902050, S/N V6L009, revealed a black, tribological coating on the balls and race wear tracks (Figure 3). It should be noted that no other bearing in the Body Flap or Rudder/Speed Brake actuators was found to contain the black, tribological coating on the wear surfaces. Minor corrosion was noted on the inner and outer raceways. The grease present in the bearing was brown in appearance due to the tribological decomposition of the Braycote 601 grease and iron oxide wear debris. The recommendation based on microscopic examination analysis was to replace the bearing since the wear surfaces were black and it suffered Brinell damage during disassembly.

Note black balls and the dark bands present on the raceways.

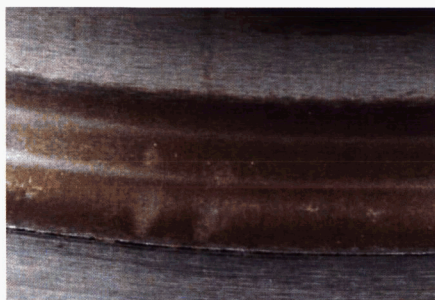
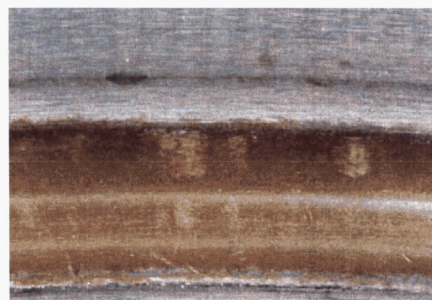
Further work performed in 2004 by Hamilton Sundstrand, Inc. reported that the inner ring contained a black tribological coated band. The black band or wear track possessed a smooth matte finish with a grain boundary like structure. Outside the black wear track, the original surface was still evident along with the original finish marks. The outer ring contained a similar black coated wear band (Figure 4). The wear surface of the outer race was similar in appearance to the wear surfaces present on the balls.

Figure 4. Magnified views of the black wear tracks in the inner race (left) and outer race (right) are shown. Note the false brinelling marks. The dark brown color is an optical aberration of the black color.

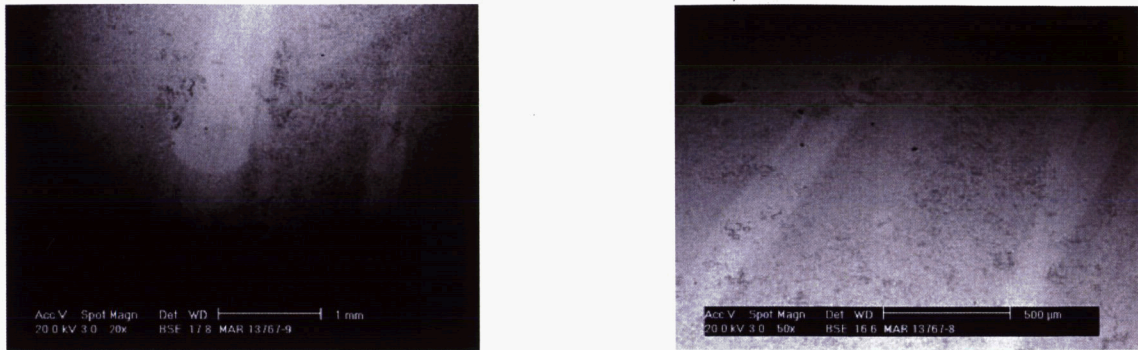
Scanning electron microscopy was performed on segments of the black ball bearing by various groups [5]. The segments examined included the balls, inner raceway and outer raceway. Analysis of the balls by energy dispersive spectroscopy (EDS) revealed that the black tribological coating was composed of carbon and iron oxide. The coating was porous and appeared to be uniform over the entire ball surface. A few skid marks were noted (Figure 5). In addition, each ball possessed a moon-shaped spot that appeared to have penetrated the burnished coating. The spot was probable caused by a drop of rain

water absorbing corrosive chemical from the degraded grease and dissolving the black coating during Shuttle storage.

Figure 5. Scanning electron micrograph of black ball showing spot (left) and skid marks (right)

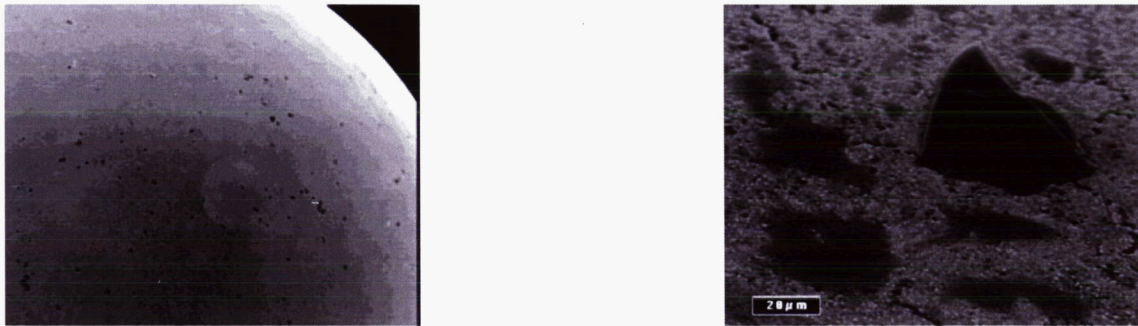
Figure 6. Scanning electron micrographs of the black ball (left) and magnification of particle present on the ball surface (right)

Higher magnification of the ball revealed some particles present on the ball (Figure 6). The presence of aluminum and silicon, in addition to other elements detected by EDS on these particles, were likely attributed to the bentonite clay additive present in the Braycote 601 grease and not contamination as was originally proposed. Analysis of the inner and outer raceways showed surfaces similar to the black ball. EDS performed on those surfaces detected the carbon iron oxide coating found on the black balls. Examination of the inner raceway away from the burnished band showed the original finishing marks which gradually translated into a smoother region as the burnished area was approached (Figure 7). Figure 8 shows the surface for the coating present on the black ball obtained by surface profilometry.

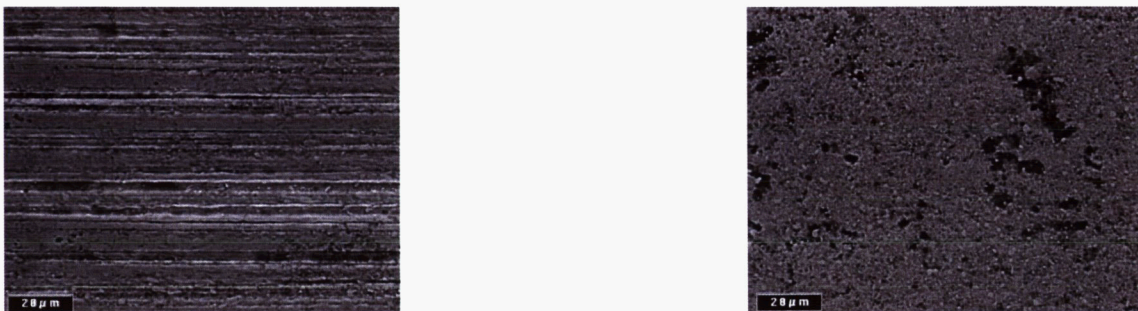
Figure 7. Scanning electron micrograph of the outer raceway in the region above the burnished band (left), and within the burnished band (right)

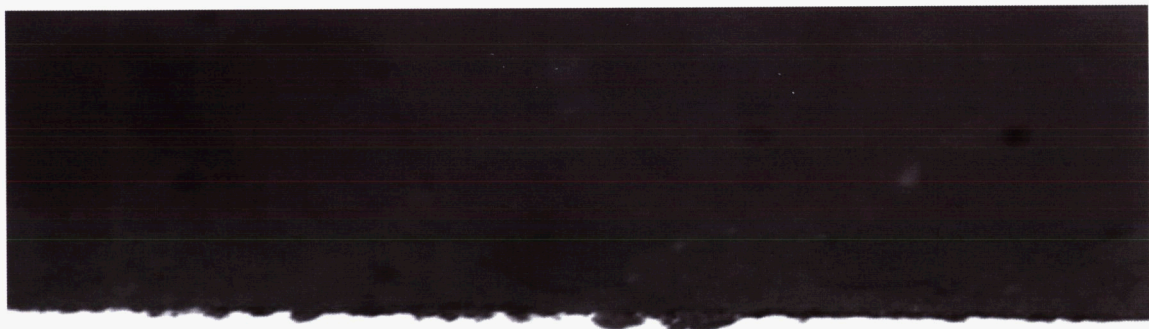
Figure 11a. Metallographic section of black bearing

A black ball and a segment of the race from the blackened bearing, S/N V6L009, were metallographic cross sectioned and the tempered martensitic 52100 steel and black tribological coating examined (Figure 10 and 11) [5]. The microstructure of the black ball was consistent with properly processed 52100 temper martensite with finely dispersed carbides with a hardness of R_c 64-65 from the surface into the ball. Tapered sections showed no evidence of annealing below the black tribological coating therefore the

temperature of the ball did not go above 204°C during the formation of the black tribological coating. The black coating appears to be a micron or two thick. Pits present on the cross-section were very shallow.

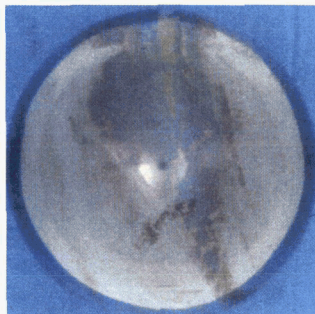
Figure 14. Ball from BF-003 after 48 Mission life test

A photograph of a ball from BF-003 is shown in Figure 14. The photograph showed some banding and blue discoloration due lubricant degradation. The test lubricant was found to be in good condition. It was creamy white in color with some brown red areas caused by the early stage of lubricant degradation.

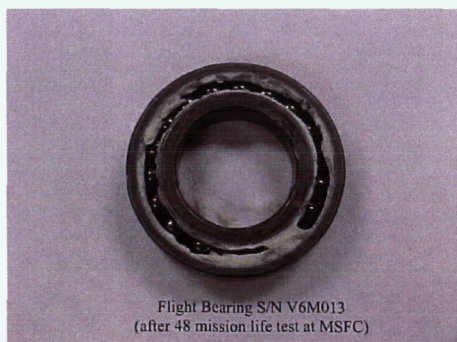
Figure 15. Flight bearing SN V6M013 after 48 mission life test

After testing, the lubricant appeared to be in good condition. The grease in the bearings was still creamy white with only a few areas of reddish brown discoloration (Figure 15). Balls from flight bearing showed significant banding due to normal wear and possible lubricant degradation (Figure 16).

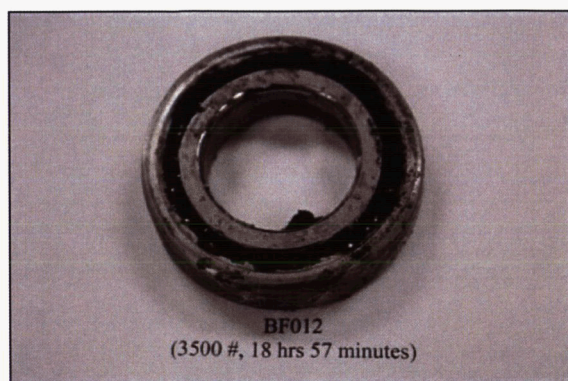
Figure 17. Failed Test Bearing BF012

In general, failed bearings exhibited severe wear. A failed bearing is shown in Figure 17 and 18. The onset of wear started when the lubricant between the ball and race was completely consumed or degraded. Shear plastic deformation occurred between the race and ball steel to cause adhesive wear or severe wear. Due to high friction and heat generation, the local ball temperatures rapidly increased and caused oxidation and discoloration of bearing balls. In some case, the balls were highly discolored and almost black. The test lubricant in the failed bearings was very dark in color with significant degradation and metallic wear debris.
